**CREEP BEHAVIOR OF AN OXIDE/OXIDE COMPOSITE WITH MONAZITE  
COATING AT ELEVATED TEMPERATURES**

THESIS

Sean S. Musil, 1st Lt, USAF  
AFIT/GAE/ENY/05-M14

***AIR FORCE INSTITUTE OF TECHNOLOGY***

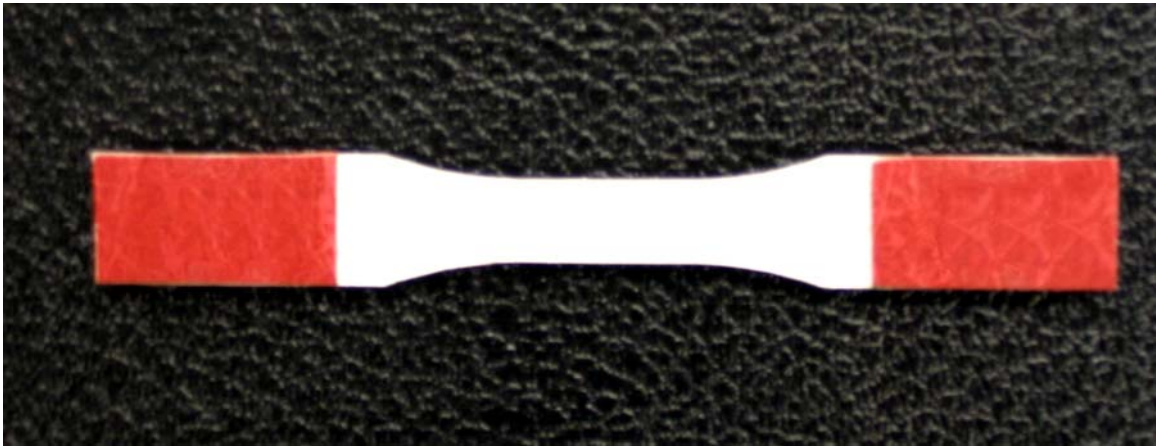
Figure 11. Tabbed Test Specimen

tabbed and tab surfaces were cleaned using M-Prep Neutralizer. The tabs were then coated with an M-Bond Catalyst to ensure secure bonding of the tab to the specimen. Five drops of M-Bond Adhesive in a “X” pattern were used to bond the tab to the specimen. Pressure was applied for 15 seconds to evenly distribute adhesive and create a strong bond. An example of a tabbed specimen can be seen in Figure 11.

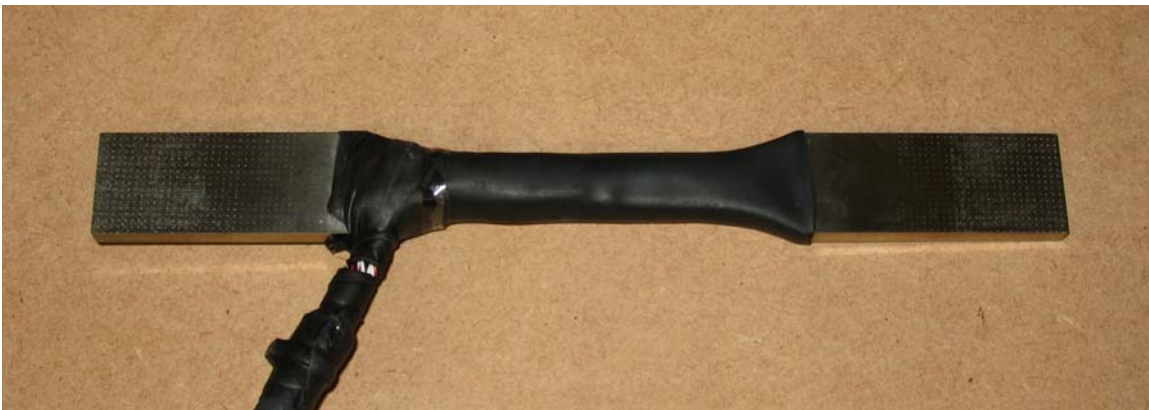
Figure 12. MTS 609 Alignment Fixture

Prior to testing, the grips were aligned using an MTS 709 Alignment System consisting of an MTS 609 Alignment fixture fitted with twelve strain gages and MTS 709 Alignment Software. The alignment specimen's strain levels were zeroed out, and then gripped under no load. The position and rotation of the right grip was then adjusted using the alignment fixture until the strain levels were again close to zero. This procedure eliminated any bending or twisting stresses on test specimen caused by improper alignment of the grips. The MTS Alignment Fixture is shown in Figure 12.

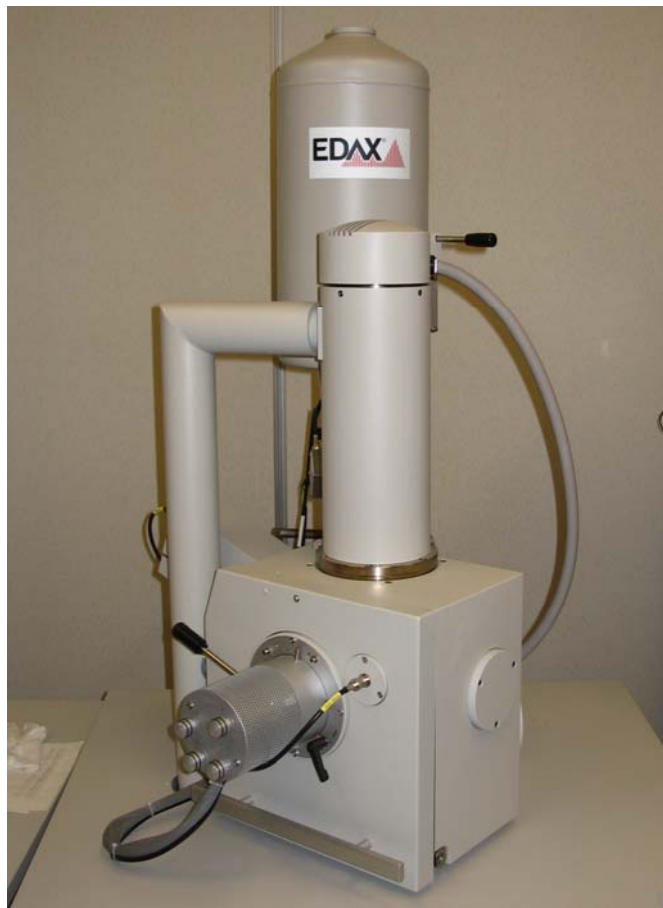
Figure 20. FEI Quanta 200 HV Scanning Electron Microscope

SEM analysis was accomplished using a FEI FP 2011/11 Quanta 200 HV Scanning Electron Microscope shown in Figure 20. This form of microscope bombards the specimen with electrons and builds an image from those electrons that are reflected. Since ceramic materials are not good conductors and tend to build up a charge of electrons which distorts the SEM image, the specimens were coated with a conductive layer of gold prior to analysis. The gold coating was applied using an SPI MODULE 11430 Sputter Coater shown in Figure 21.

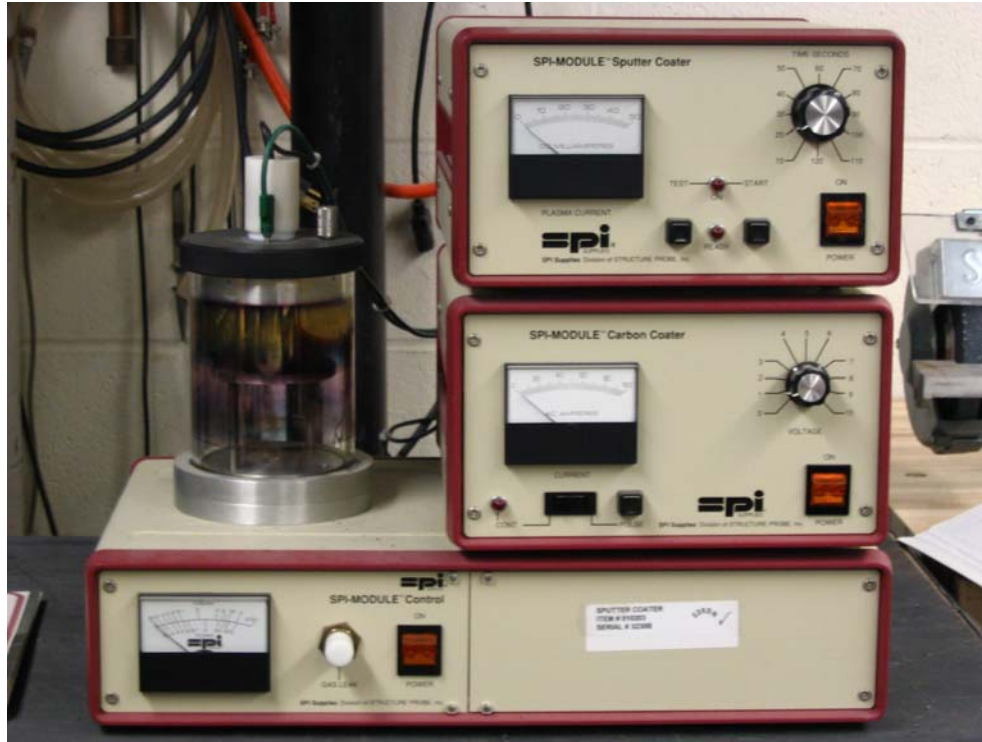
Figure 21. SPI MODULE Sputter Coater

The sputter coater uses positively charged argon gas ion plasma in a vacuum sealed chamber to strike a gold target knocking off the metal atoms which fall onto the specimen below. Prior to coating, the fractured specimen halves were cut down to a length that was usable in the SEM and mounted to an SEM test stand. Figure 22 below shows a coated specimen attached to a stand for use in the SEM.

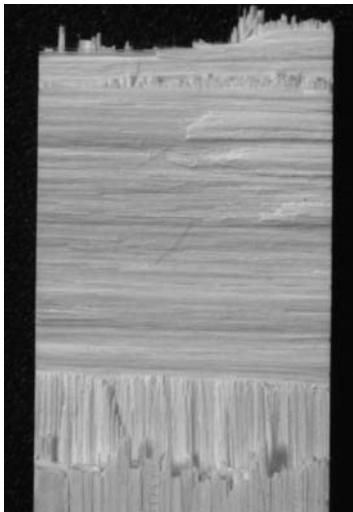
Figure 28. Tensile Fracture Surface of N610/Alumina at 23°C

Fracture surfaces for N610/Alumina specimens obtained from monotonic tensile tests display nearly planar fractures at different locations in each ply. The location at which each ply failed corresponded to the location of the most fiber fractures within the ply. Tensile fracture surfaces are shown below for N610/Alumina at 23°C in Figure 28, 1100°C in Figure 29, and at 1200°C in Figure 30. Specimen width is approximately 10 mm for all specimens.

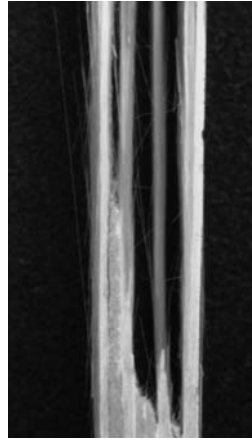
Figure 42. Tensile Fracture Surface of N610/Mon/Alumina at 1100°C (Side)

Side views of the tensile fracture surfaces indicate uniform pullout in each of the 0° layers. They can be seen for tensile tests performed at 900°C in Figure 40, 1000°C in Figure 41, 1100°C in Figure 42, and at 1200°C in Figure 43.

Failure of the 90° plies are basically planar and occurred at or near the same level in the composite. Matrix cracks could have propagated through each layer deflected around the fibers by the monazite coating and, in some cases, traveled along a debonded fiber socket causing failure in the next transverse ply at a slightly different level. Specimens that show 90° layer failures at very different levels indicate multiple flaws could have caused the separation in failure planes.

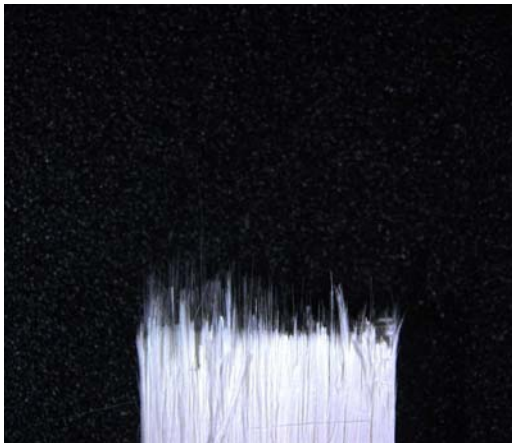
Figure 69. Creep Fracture Surface of N610/Mon/Alumina at 1100°C, 40 MPa

Figure 70. Creep Fracture Surface of N610/Mon/Alumina at 1100°C, 80 MPa

Figure 72. Creep Fracture Surface of N610/Mon/Alumina at 1100°C, 120 MPa

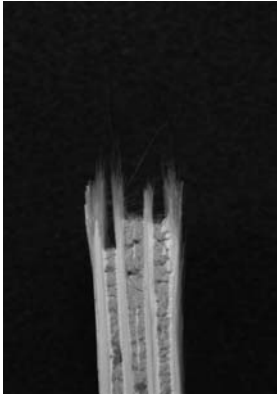
Figure 73. Creep Fracture Surface of N610/Mon/Alumina at 1100°C, 40 MPa (Side)

Side views of these fracture surfaces can be seen in Figure 73 from a creep stress of 40 MPa, in Figure 74 from a creep stress of 80 MPa, in Figure 75 from a creep stress of

100 MPa, and in Figure 76 from a creep stress of 120 MPa. Specimen thicknesses are all approximately 3.6 mm.
